Approach

NAVAL AVIATION SAFETY REVIEW

THING from NOTHING

Published by U. S. Naval Aviation Safety Center

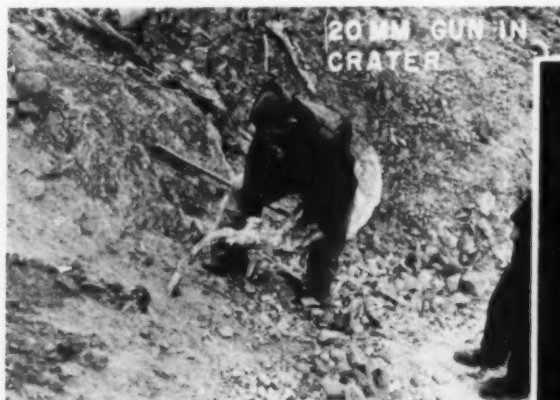
Confronted with a rocky hole in a remote mountain-side, investigators determined angle of impact from gunbarrel imbedded in rock, and tediously screened for significant pieces of wreckage.

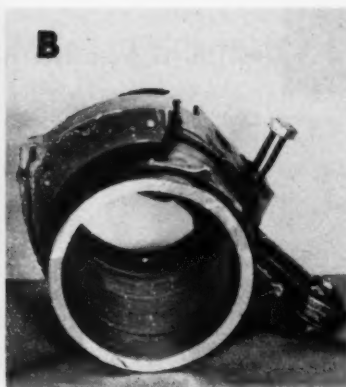
Evidence obtained from recovered parts such as the jack screw and shift assembly sector, pictured above revealed such important information as the nose-down stabilizer actuator position and that the shift sector position was in the manual position on impact.

To establish the trim position of the Cougar's flying tail at the moment of impact, investigators duplicated on a new actuating cylinder, the position of the movable parts recovered from the wreckage (see insert).

First, they observed that the trim position at the moment of impact was at the limit of nose-down travel (4½ degrees). This was established by the position of the acme screw with its follow-up fitting.

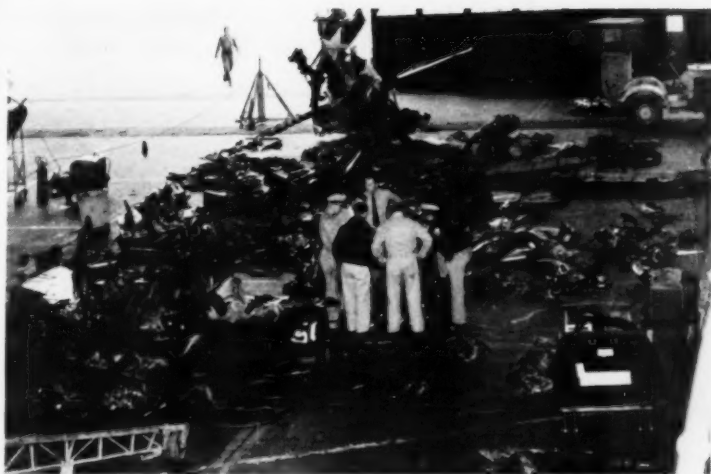
When all the parts have been collected, as illustrated in this instance of a layout made in a hangar, the investigator's task has just begun.

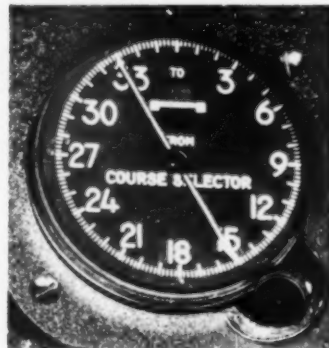
Fig. 5—A course selector from the ARN-30. In this case the selector course would be 150 degrees. The To-From indicator is centered indicating that the equipment is not operating.

The course selector is manually operated by the knob on the lower right-hand side and any desired course from 0 to 360 degrees can be selected. The To-From indicator is the small window appearing in the top half of the course selector. In operation the pointer bar moves up or down pointing either to the word "to" or "from."

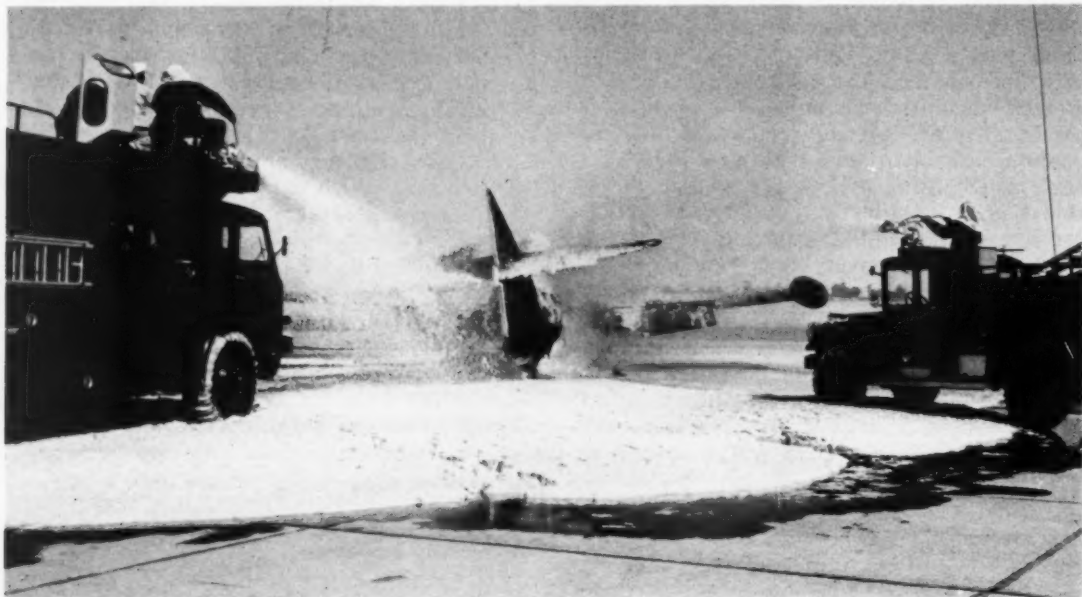
Even the newest fire fighting equipment is ineffectual without proper training and techniques.

The new type trucks, the MB1 and MB2, carry crews of five and three respectively, and provide a fire fighting potential never before equalled. The MB1, for example, is capable of covering a burning aircraft with 12,000 gallons of foam in two minutes. This 17-ton ve-

The Type MB5 crash and rescue truck is under contract with delivery anticipated during the fall of 1956. The GVW is 15,000 lbs. mounted on a 4x4 chassis and powered with a 200-hp. 8-cylinder engine rear-mounted. The truck will carry 400 gallons of water and 25 gallons of foam. A special insulated body, equipped with bus doors, hose reel, bayonet piercing nozzle, 2-way radio, search light and flood lights.

All valves, hose line, pumps, plumbing controls and liquid tanks are located inside a single roomy van type body. The Navy new dry chemical extinguishing agent will be included. A separate gasoline auxiliary power unit to recharge batteries and operate a power

hicle can attain a speed of 64 miles an hour and possesses a mud and sand mobility equal to the finest Army combat trucks. Featuring two independent foam generating systems, the MB1 can, through its manually operated turret nozzles, throw variable patterns to a range of 180 feet.

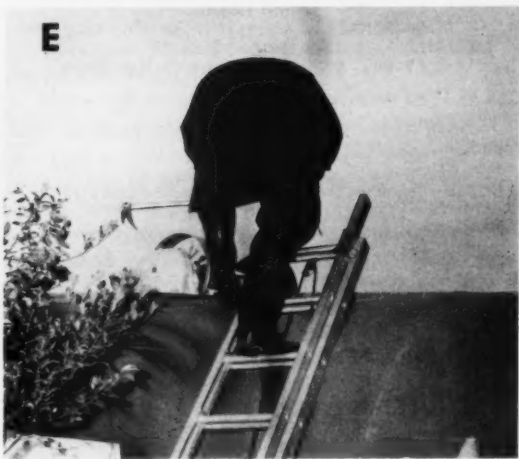
E

E. Foreknowledge of aircraft crash entry points means vital seconds saved.
